OMAP3530/25/15/03 Applications Processor
Silicon Revisions 3.1, 3.0, 2.1, and 2.0

Silicon Errata

Literature Number: SPRZ278E
February 2008–Revised March 2010

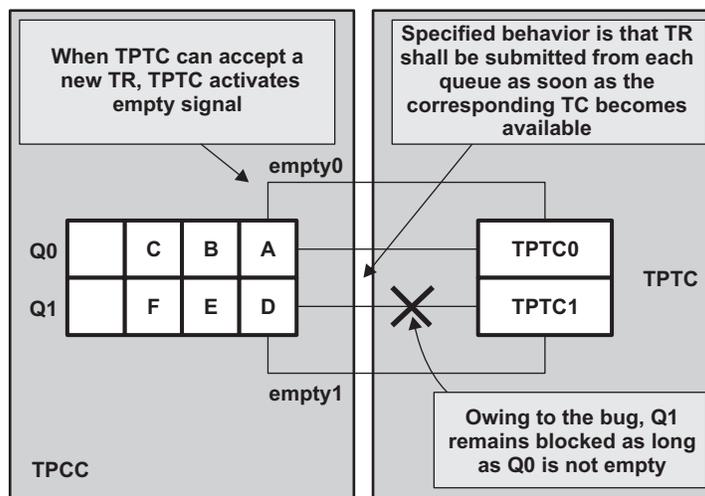
Figure 3. TR Submission Scheme

Details The EDMA channel controller (TPCC) has 2 event queues: Q0 and Q1. Each queue can be mapped to one of the two Transfer Controllers (TPTC): TPTC0 or TPTC1. As explained in the *OMAP35x Technical Reference Manual* (literature number [SPRUF98](#)), the events in each event queue will be extracted as soon as the corresponding TPTC is available for a new Transfer Request (TR) to be programmed into the TPTC. However, due to an issue in the IVA2.2 subsystem, the requests queued in Q1 cannot be submitted to their TPTC as long as Q0 is not empty.

Workaround(s) Infrequent short transfers (e.g., latency critical synchronized transfers to/from peripheral) must be placed in Q0, and longer transfers (e.g., block copy) in Q1. For example, when a latency critical transfer is placed in EDMA and a longer transfer in QDMA, the following programming model will minimize the impact of this limitation:

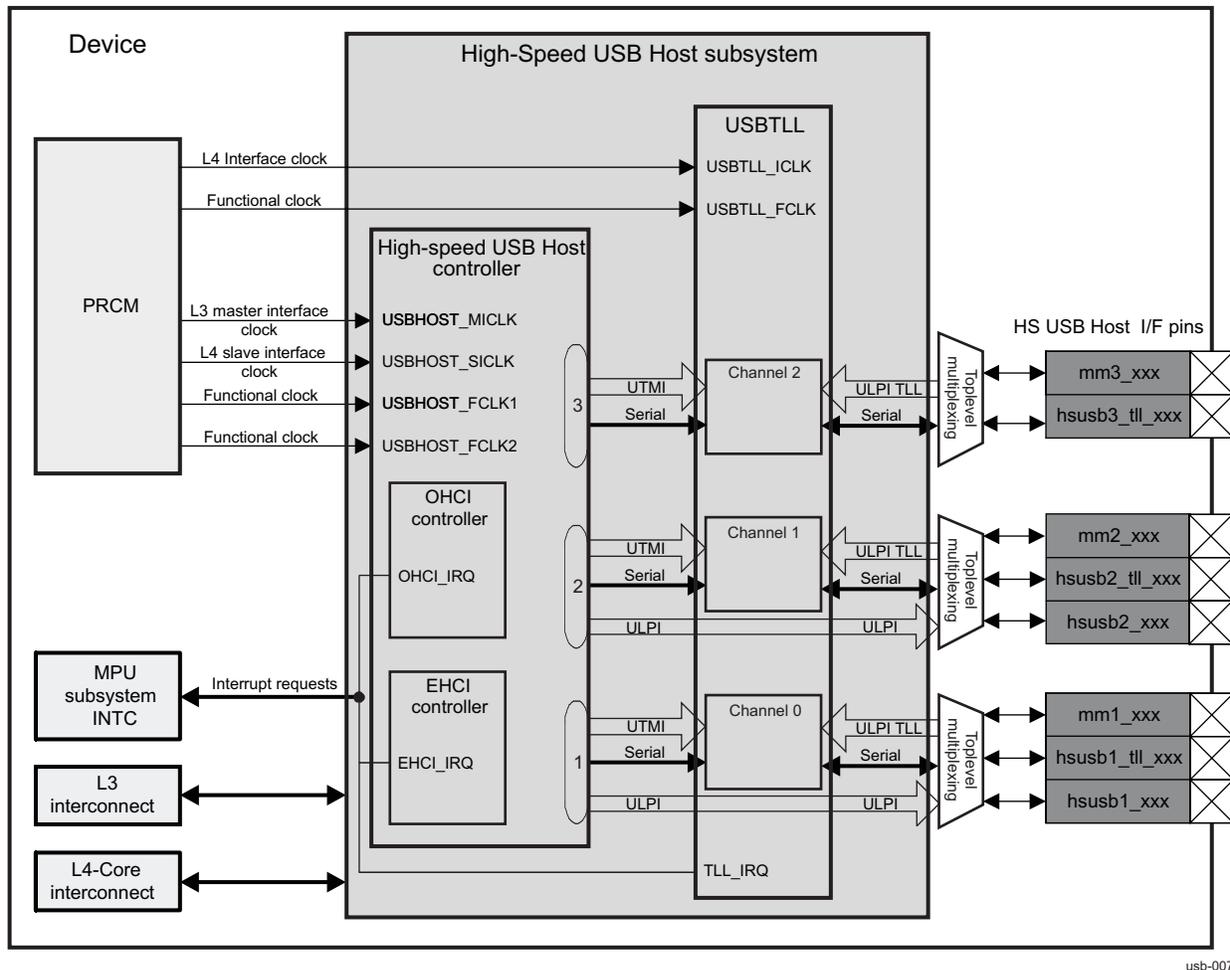
Figure 9. High-Speed USB Host Subsystem Highlight

- On silicon revision 3.0 and earlier, if one port is configured in the ULPI mode, then all other ports must use the same configuration. Therefore, the ports must be configured high-speed mode or full-speed/low-speed mode.
- USB Port 3 cannot operate in ULPI mode; it can only operate in serial or ULPI TLL mode. Furthermore, USB Port 3 is not available in the CUS package.

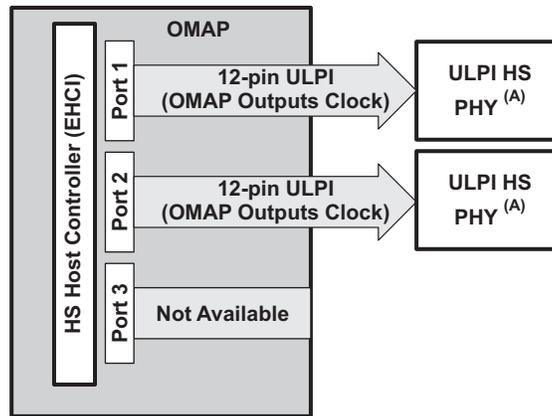
Figure 10. Connecting to High-Speed PHYs Using USB Ports

As shown in Figure 10, USB Port 1 and Port 2 can be used to connect to external high-speed PHYs which include a ULPI port. However, in this case, the external USB PHY must be able to accept a source clock generated by the OMAP high-speed USB controller. Also, in this usage model the USB ports cannot support full-speed and low-speed operation. Therefore, using this approach, USB Port 1 and Port 2 cannot provide a fully compliant USB 2.0 Type-A receptacle; a high-speed USB hub would be required in this case; please see Figure 11.

A. USB port 3 does not support ULPI mode.
Also, USB port 3 not available on CUS package.

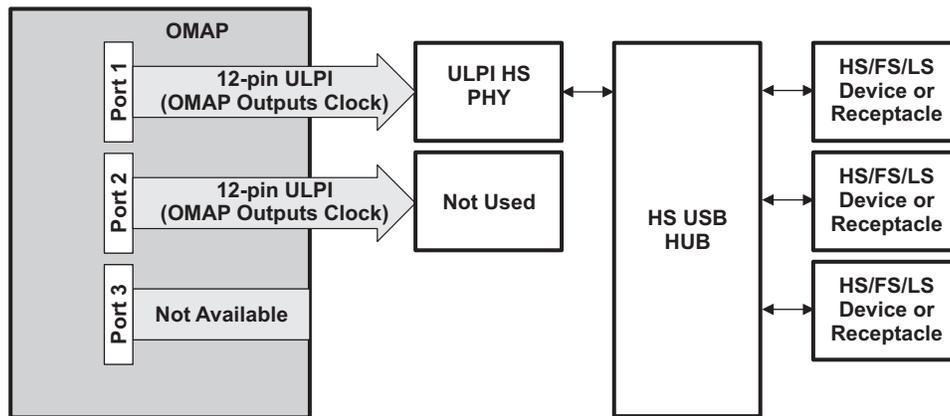
Figure 11. Connecting to a High-Speed USB Hub

A. USB port 3 does not support ULPI mode. Also, USB port 3 not available on CUS package.

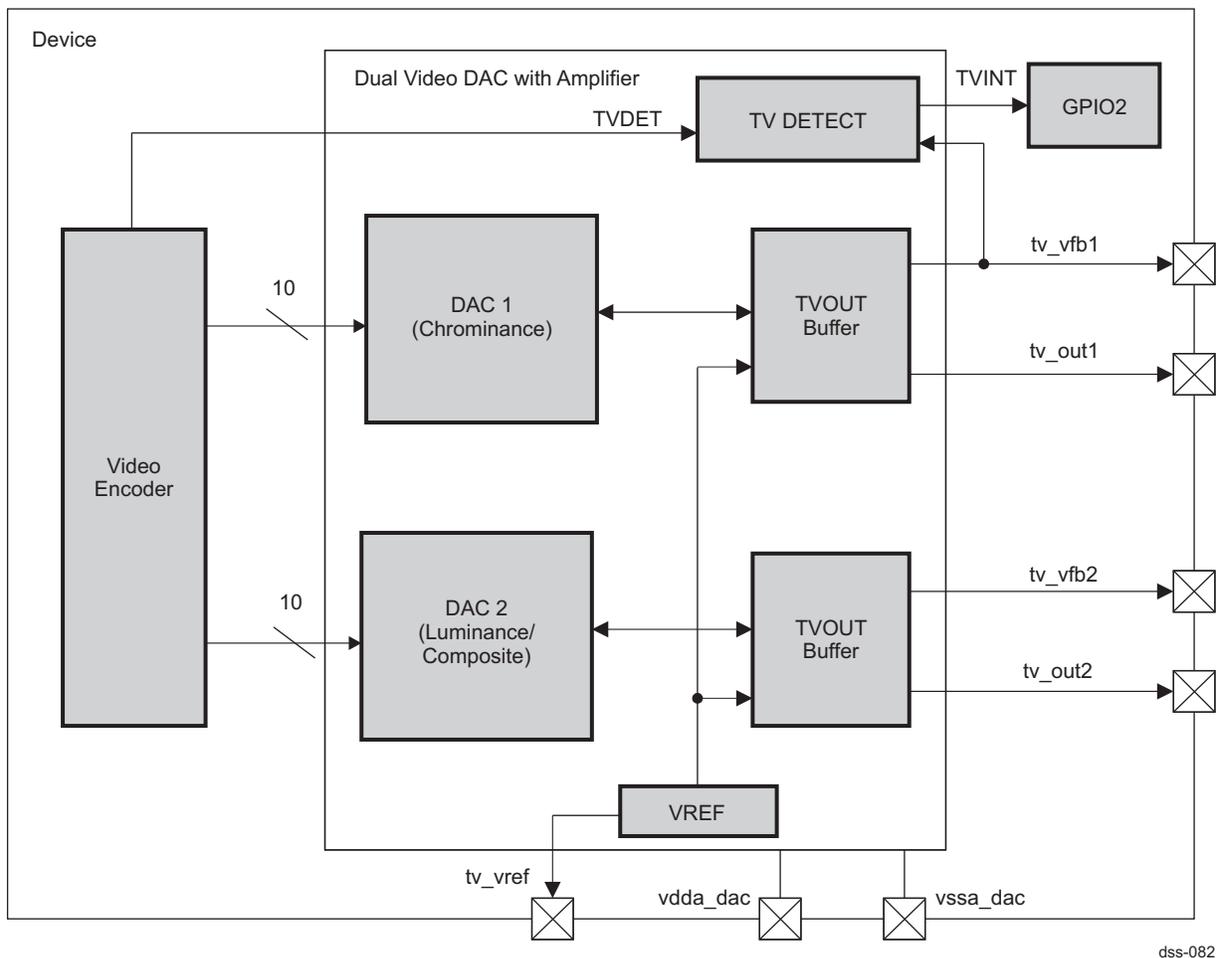
Figure 12. DAC Implementation

Furthermore, for proper TV detection in composite video mode (CVBS), DAC1 should be used for luminance and DAC2 for chrominance. Therefore, as a direct consequence of implementation, the TV detect feature is not available for composite video mode.

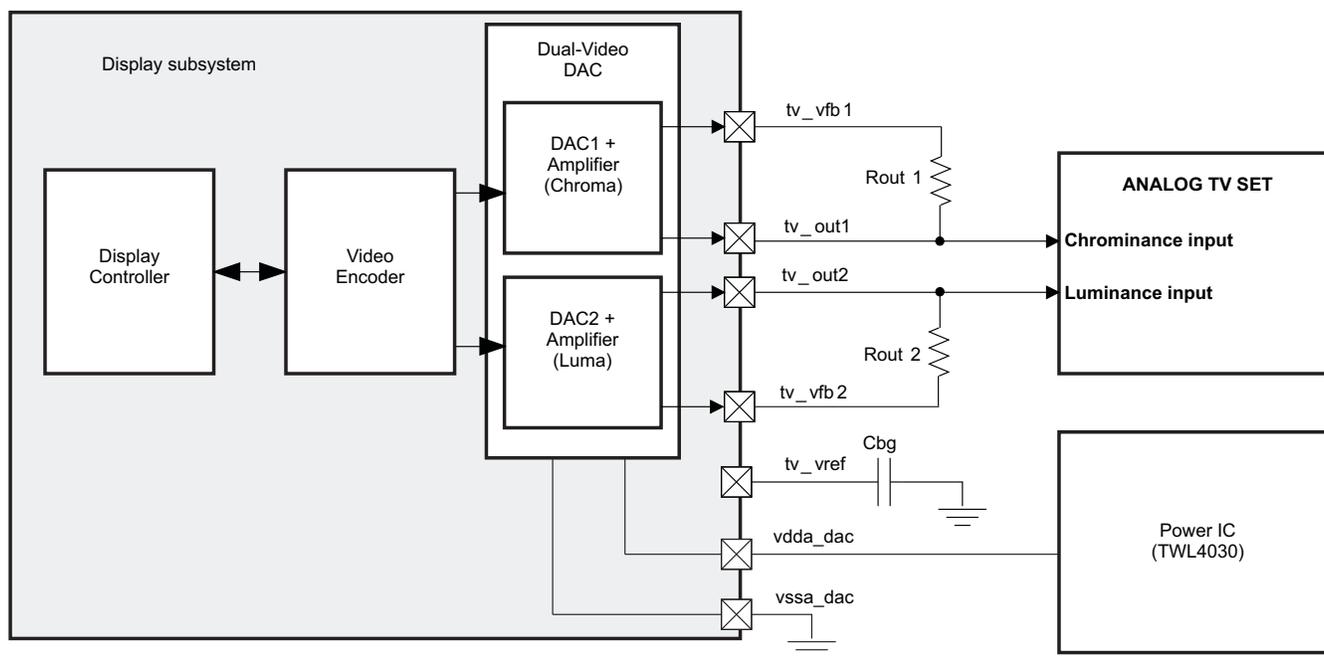
Figure 13. External Connection to TV Set

There is no workaround for the TV detect functionality. This feature is unavailable in *composite* video mode.

Workaround(s) For proper TV out functionality, the external connection to the TV set must follow the implementation shown in [Figure 13](#).
